Monte Cristo Bridge Hydraulic Design

GeoEngineers' river team and engineers help design an award-winning rural bridge

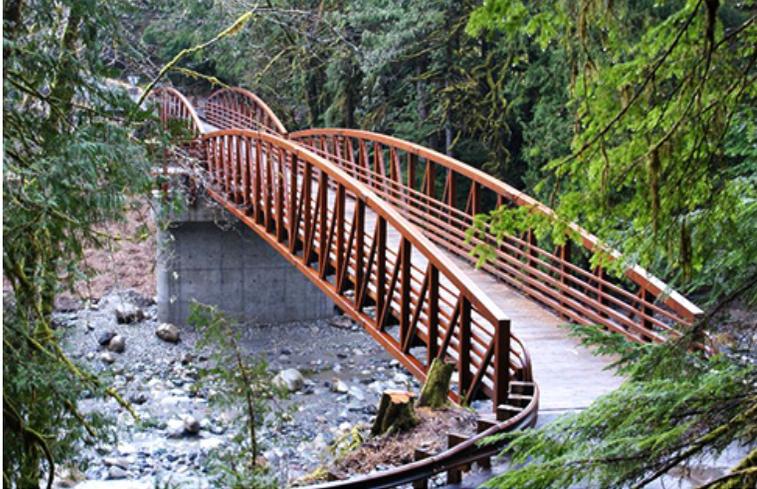
The new Monte Cristo bridge occupies an abandoned railroad grade.
